Update on Nagaoka CO2 Storage Project

Koji Hachiyama

Ministry of Economy, Trade and Industry (METI), Japan

Overview of the Nagaoka Project

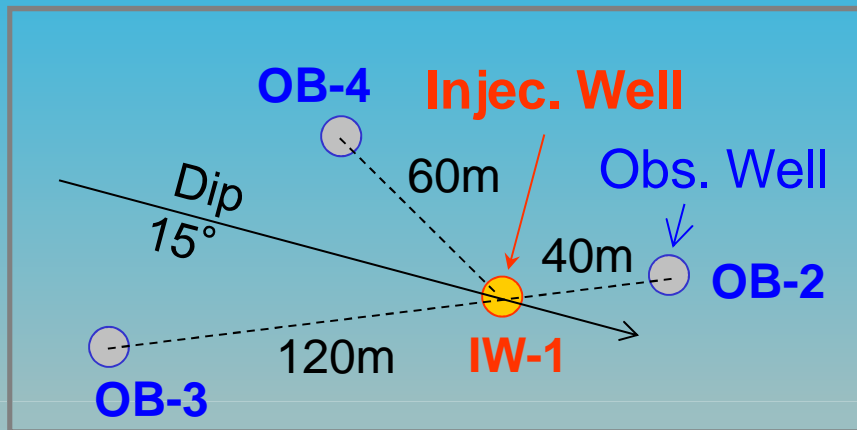
Well Configuration at the Reservoir Depth

- Injec. Period; Jul. 2003~Jan. 2005
- Total amount; 10,400 ton CO₂
- Rate; 20~40 ton/day

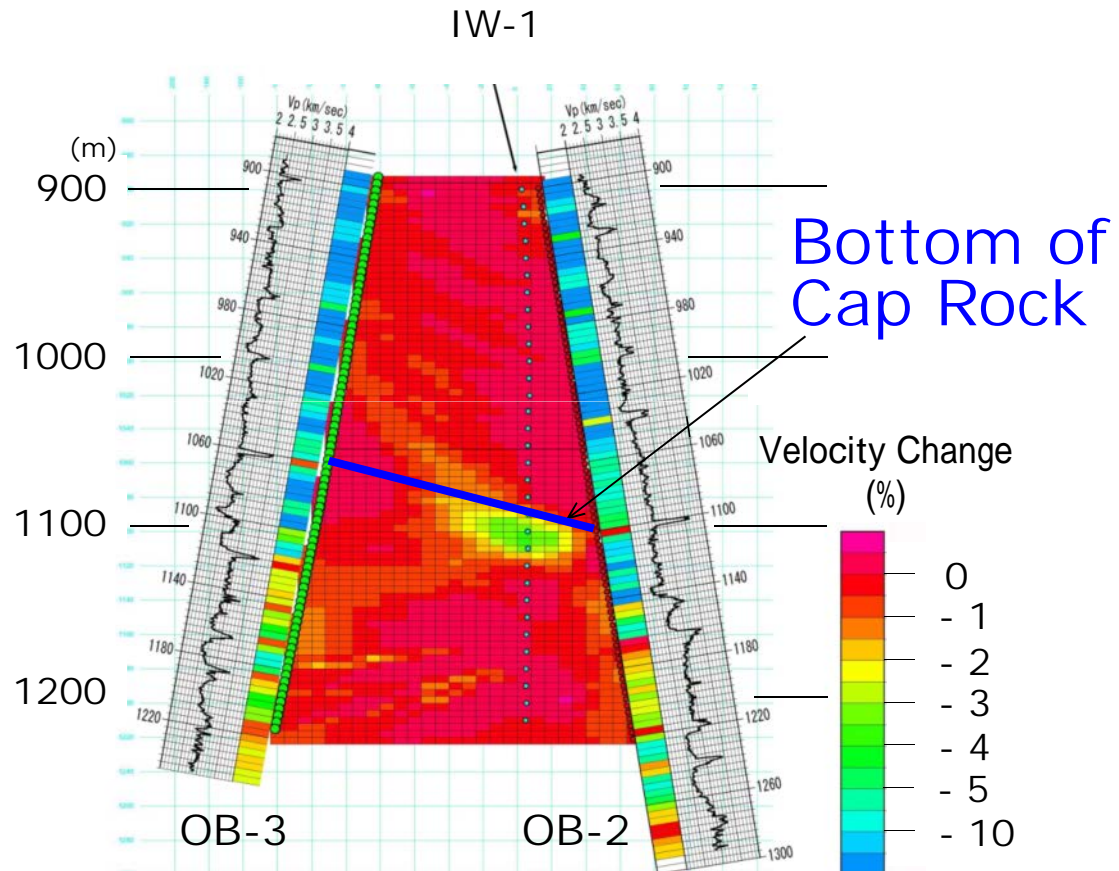
Structural Trapping

Seismic tomography → structurally trapped by cap rock

Post-Injection:
10,400t-CO₂

Max. Velocity Change = -3.5%

$$\text{Velocity Change} = (V_{MS4} - V_{BLS}) / V_{BLS}$$

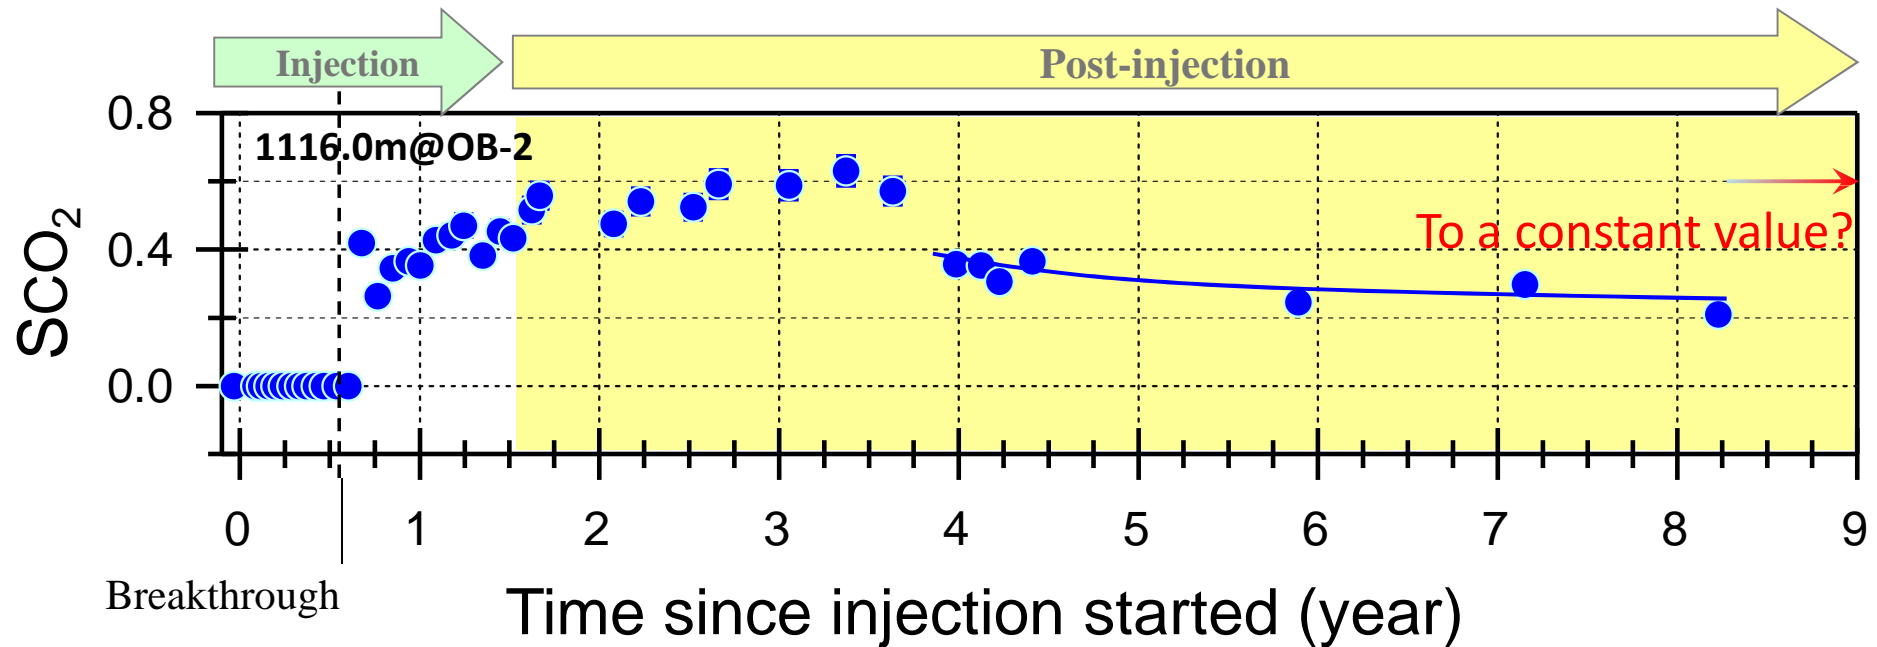
Residual CO₂ Trapping

CO₂ saturation data converging with a constant value
➔ residual gas trapping?

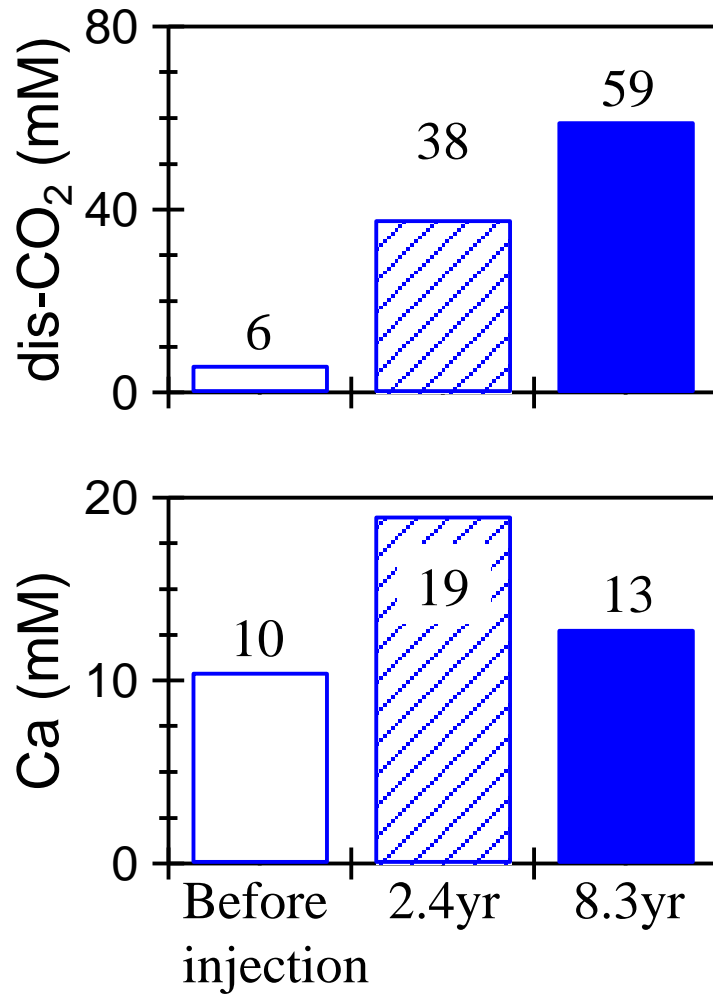
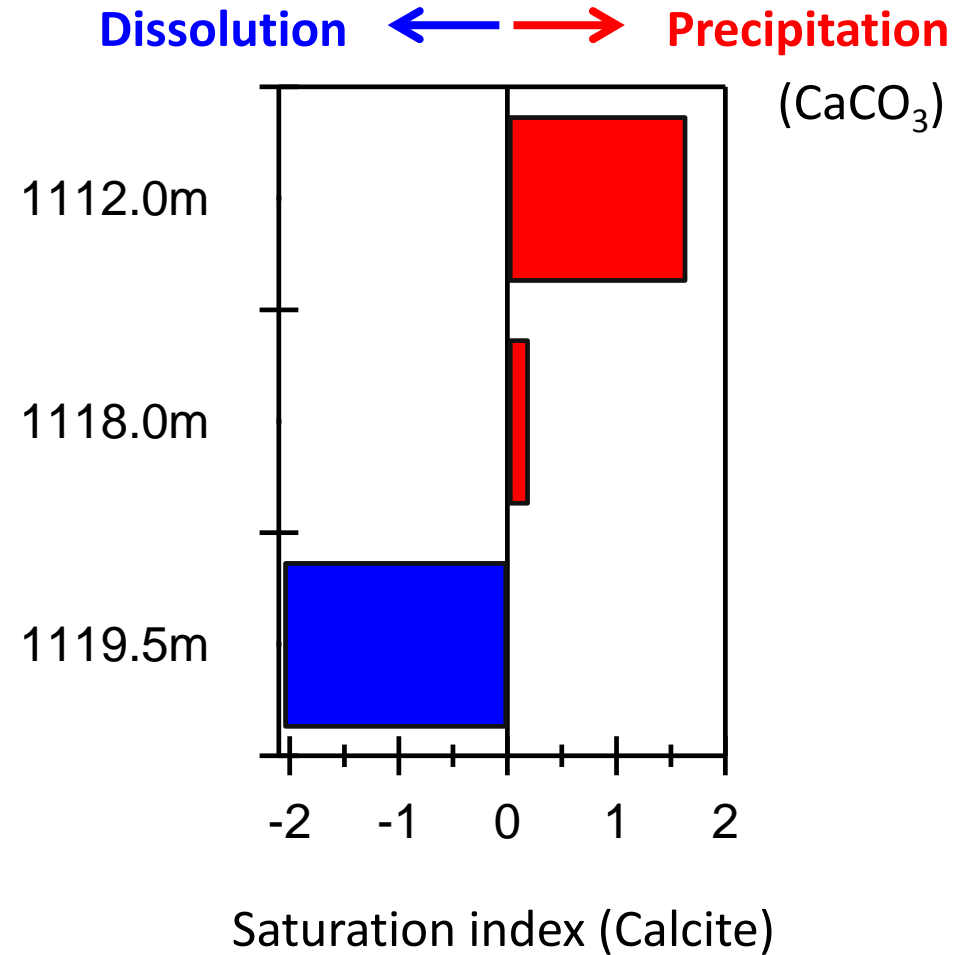
Mineral Trapping

Fluid Analyses → Mineral Trapping?

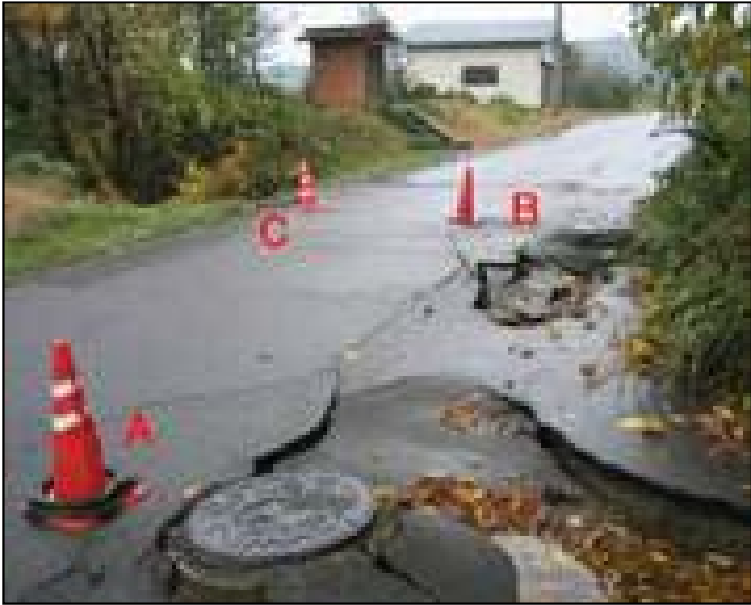
Access Road
to the Site
Damaged

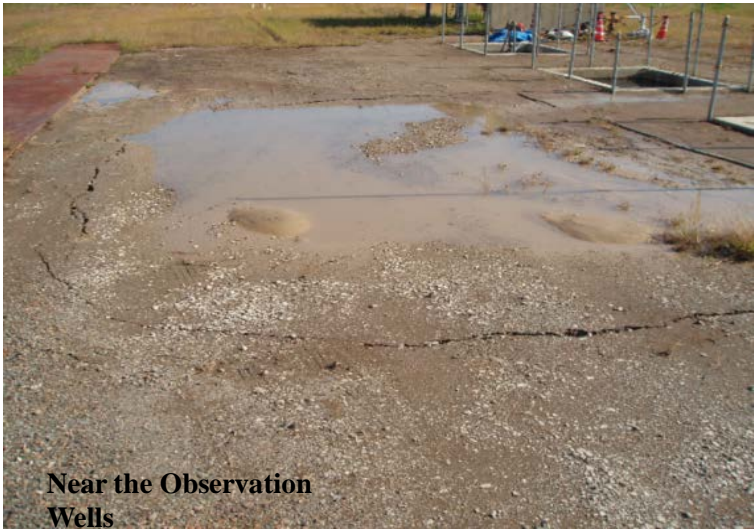
Surface around the
Wells Liquefied

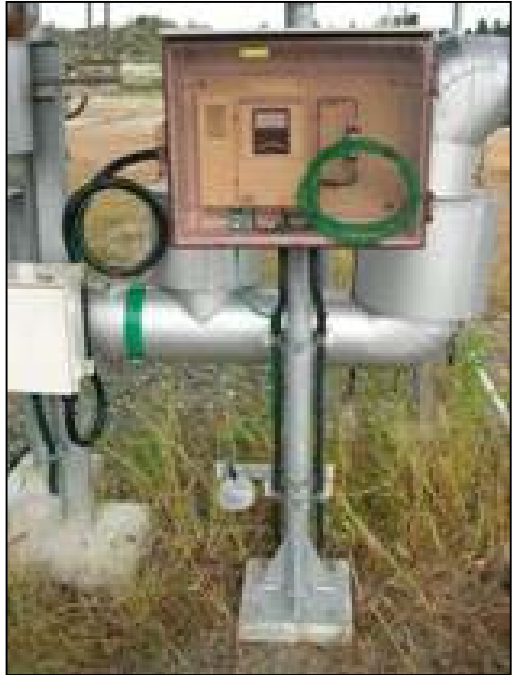
Onsite CO₂ Detector
Detected No Leakage

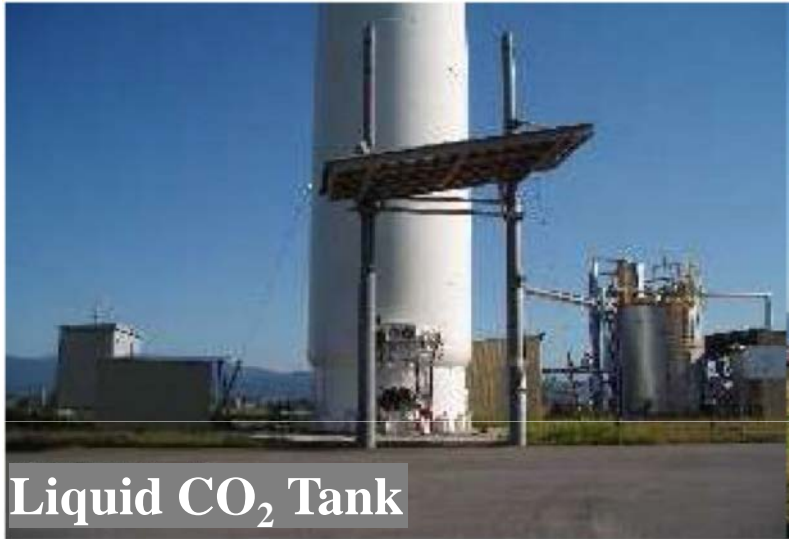
All facilities have no damage identified.

Liquid CO₂ Tank

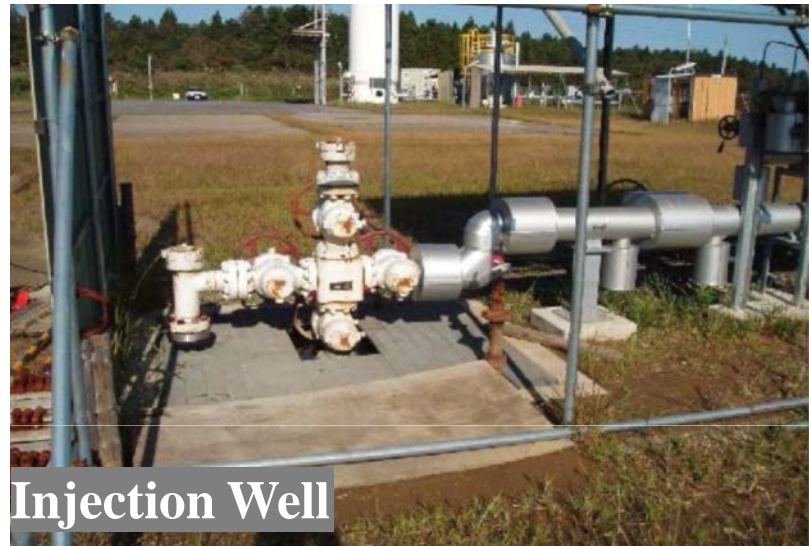
Injection Well

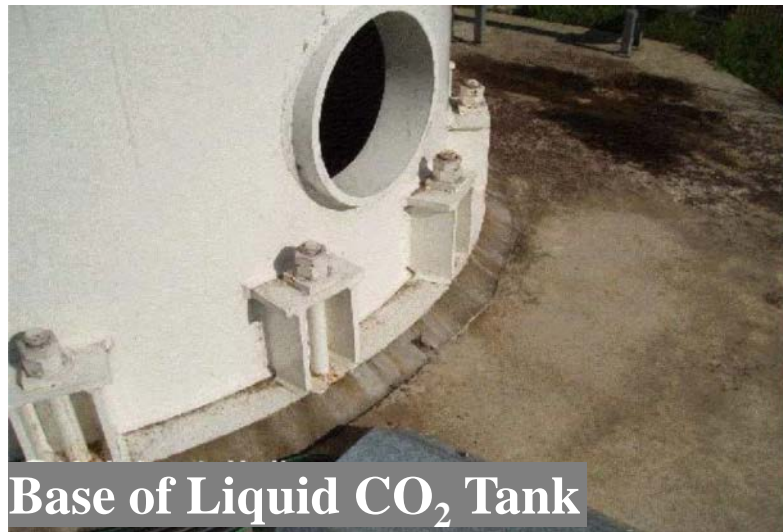
Base of Liquid CO₂ Tank

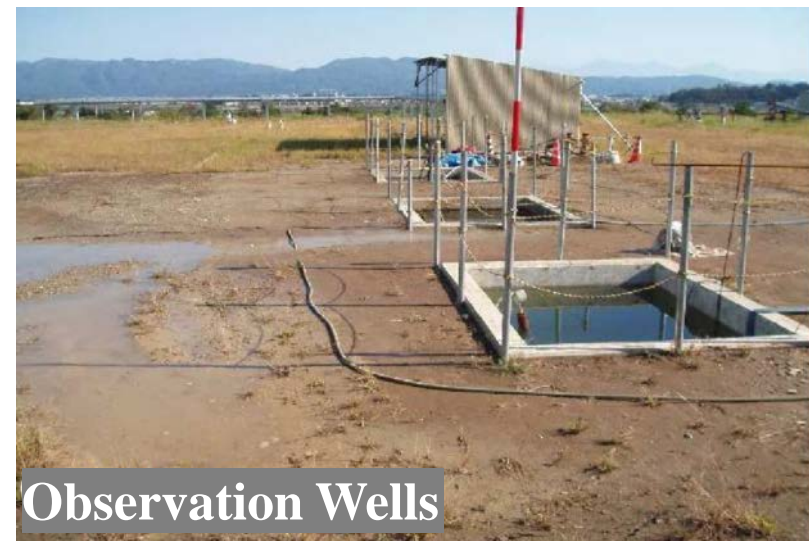
Observation Wells

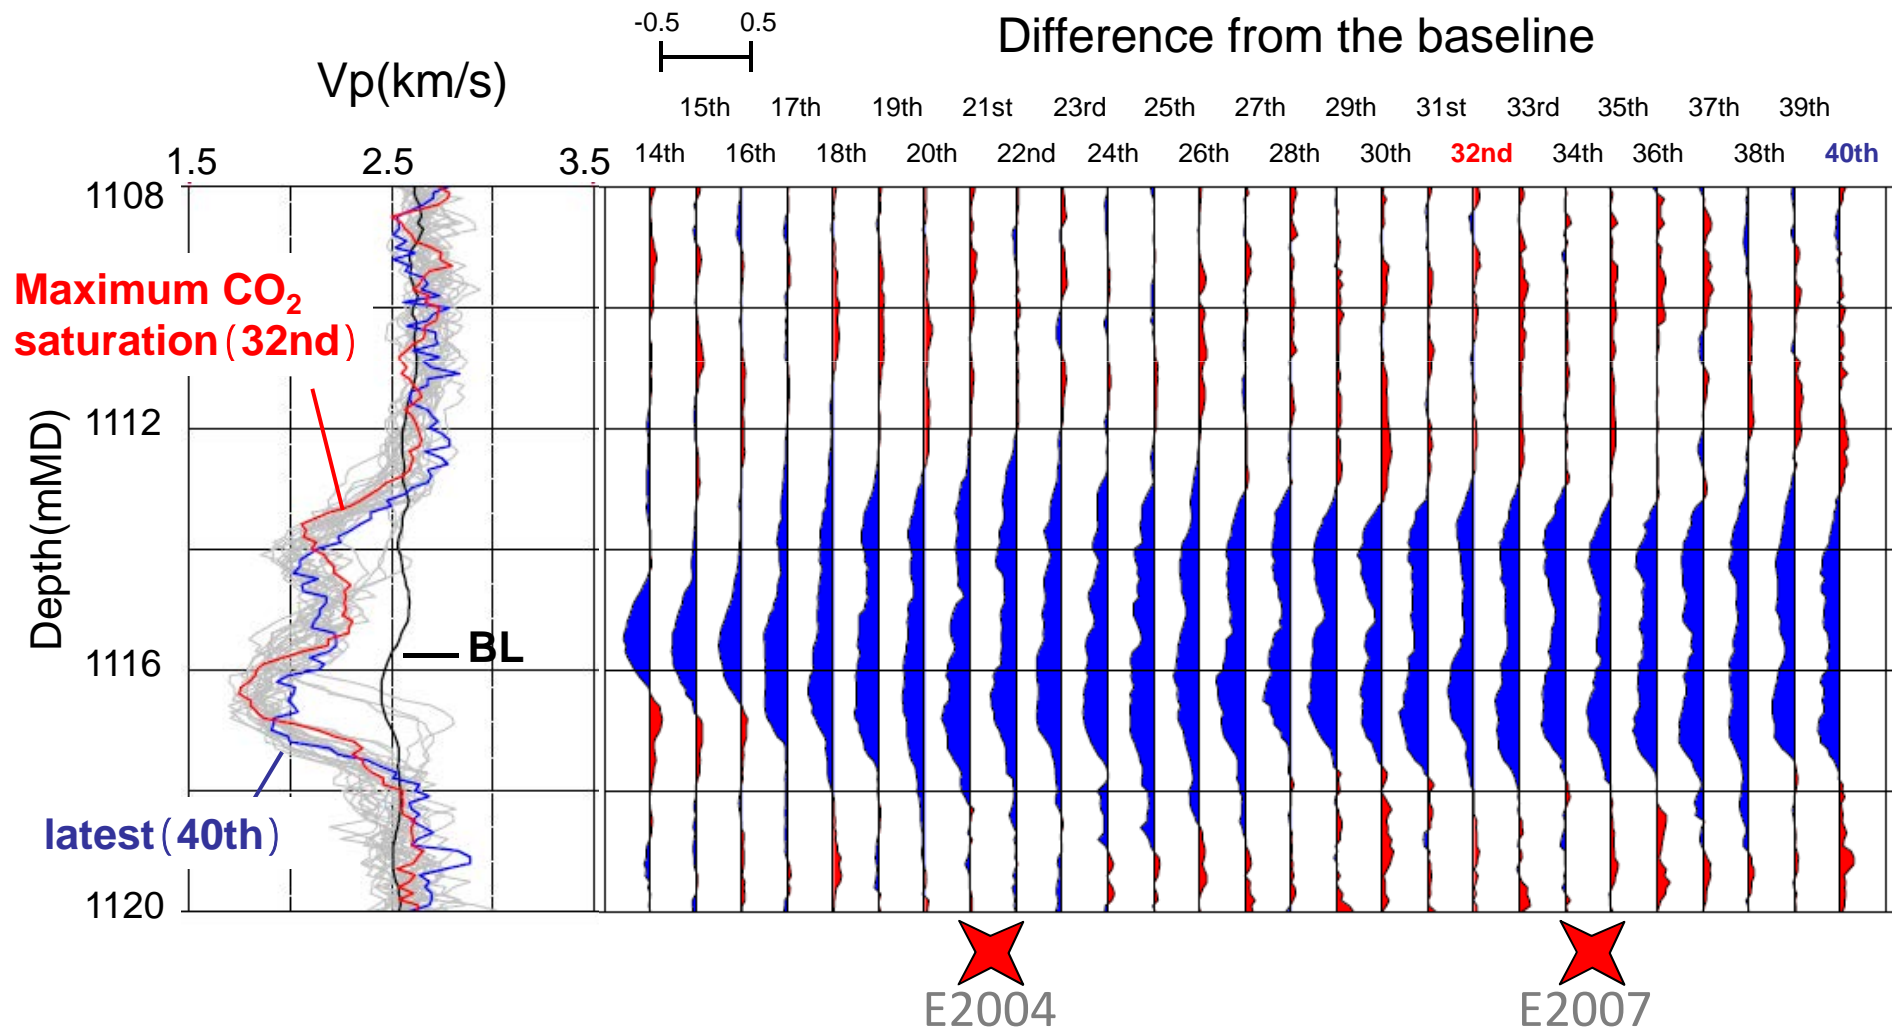
Sonic Logging Data at Observation Well 2

Sonic logging data →
No irregular changes before and after the two earthquakes

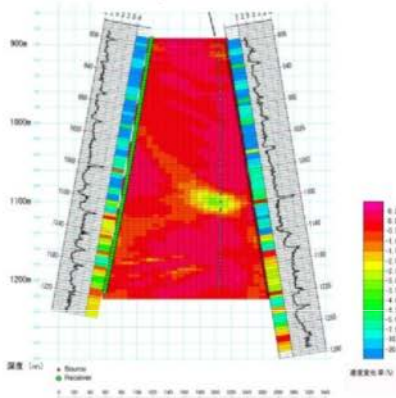
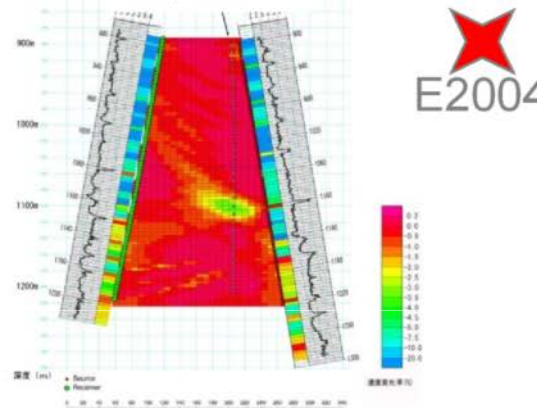
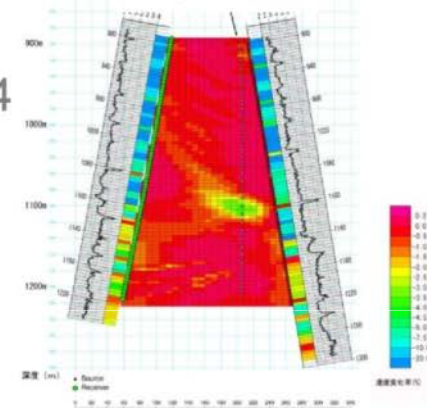
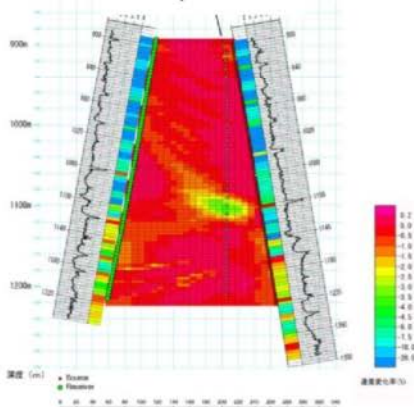
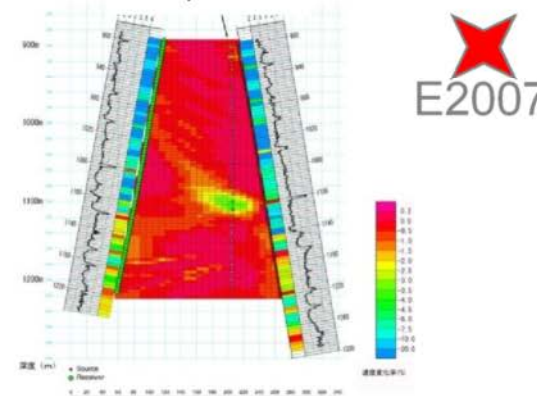
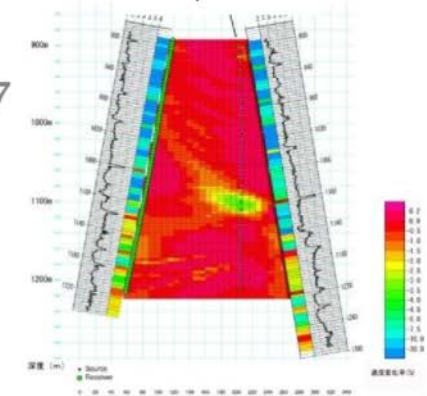
Seismic Tomography Data

Seismic tomography data →

No irregular changes before and after the two earthquakes.

MS1/BL
3,200t

MS2/BL
6,200t

MS3/BL
8,900t

MS4/BL
10,400t

MS5/BL
10,400t

MS6/BL
10,400t
